CERL Technical Report 99/91  
November 1999

# High Temperature Hot Water Generator Safety Valve Research at Wright-Patterson AFB, OH

## Investigation of Chronic Safety Valve Leaks

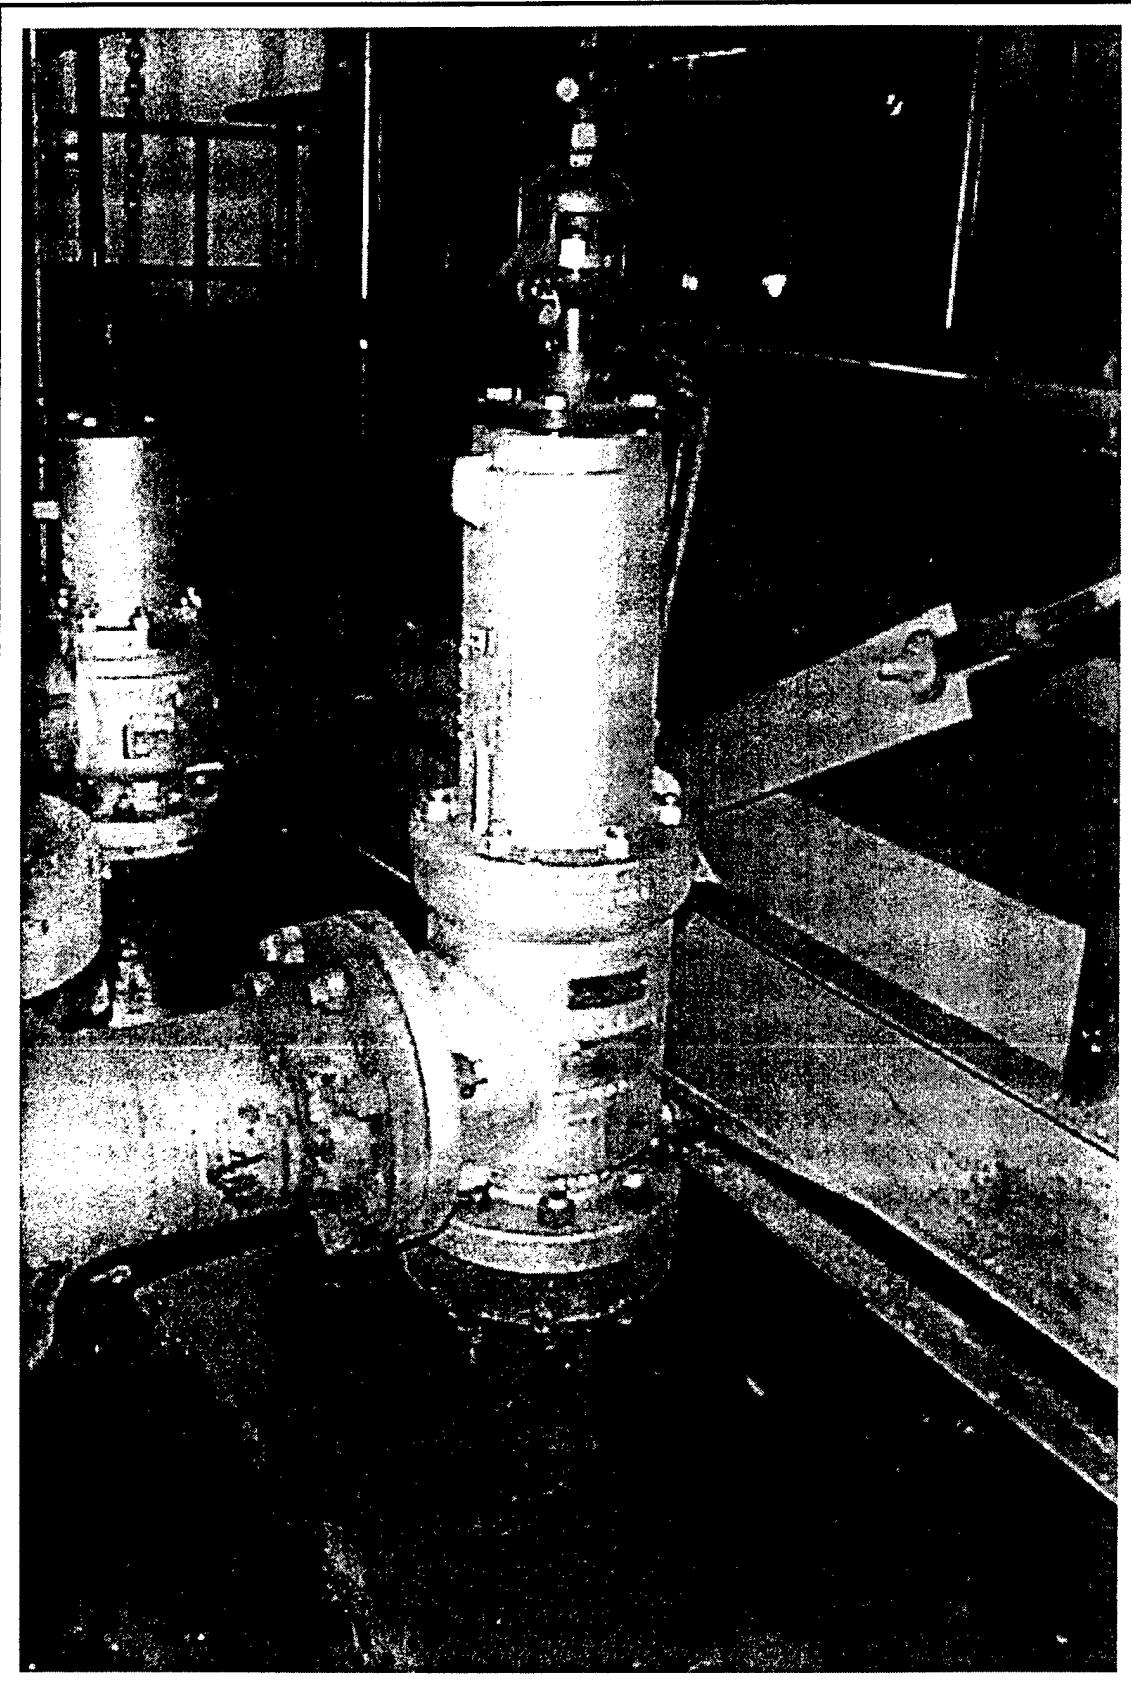
Figure 1. HTHW safety valves in Bldg 1240.

CERL and SAI conducted a site visit to WPAFB Plant 1240 on 22 December 1998. During the site visit, the investigation team examined the installed safety valves (Figure 1), reviewed plant drawings, recorded plant conditions, and interviewed plant staff. The team observed that the installed safety valves were not marked as the type required by the American Society of Mechanical Engineers (ASME) Boiler and Pressure Vessel Code (ASME BPVC) Section I Part PG-110. ASME BPVC requires fired pressure vessels to be protected with "V" stamped safety valves. Additionally, the legibility of the valve data was poor. Table 1 lists the seven items required to appear on the name plate or etched on the valve body.

Two valves are required on each of the four HTHW units, for a total of eight safety valves. Only two of the installed valves had "V" stamps. One additional valve may have had a "V" stamp, but it was hidden from view by the HTHW generator piping. Three valves had "UV" stamps. "UV" valves are not permitted on fired pressure vessels built and operated as ASME BPVC Section I systems. Two valves had neither "V" nor "UV" stamps. Appendix A to this report tabulates the legible data collected as part of this inspection.

Based on the code requirements and the available information, the team recommends that two "V" safety valves be installed on each HTHW unit. These valves should be sized to relieve the full HTHW unit capacity at 6 percent of the maximum allowable working pressure (MAWP) of 500 psig.

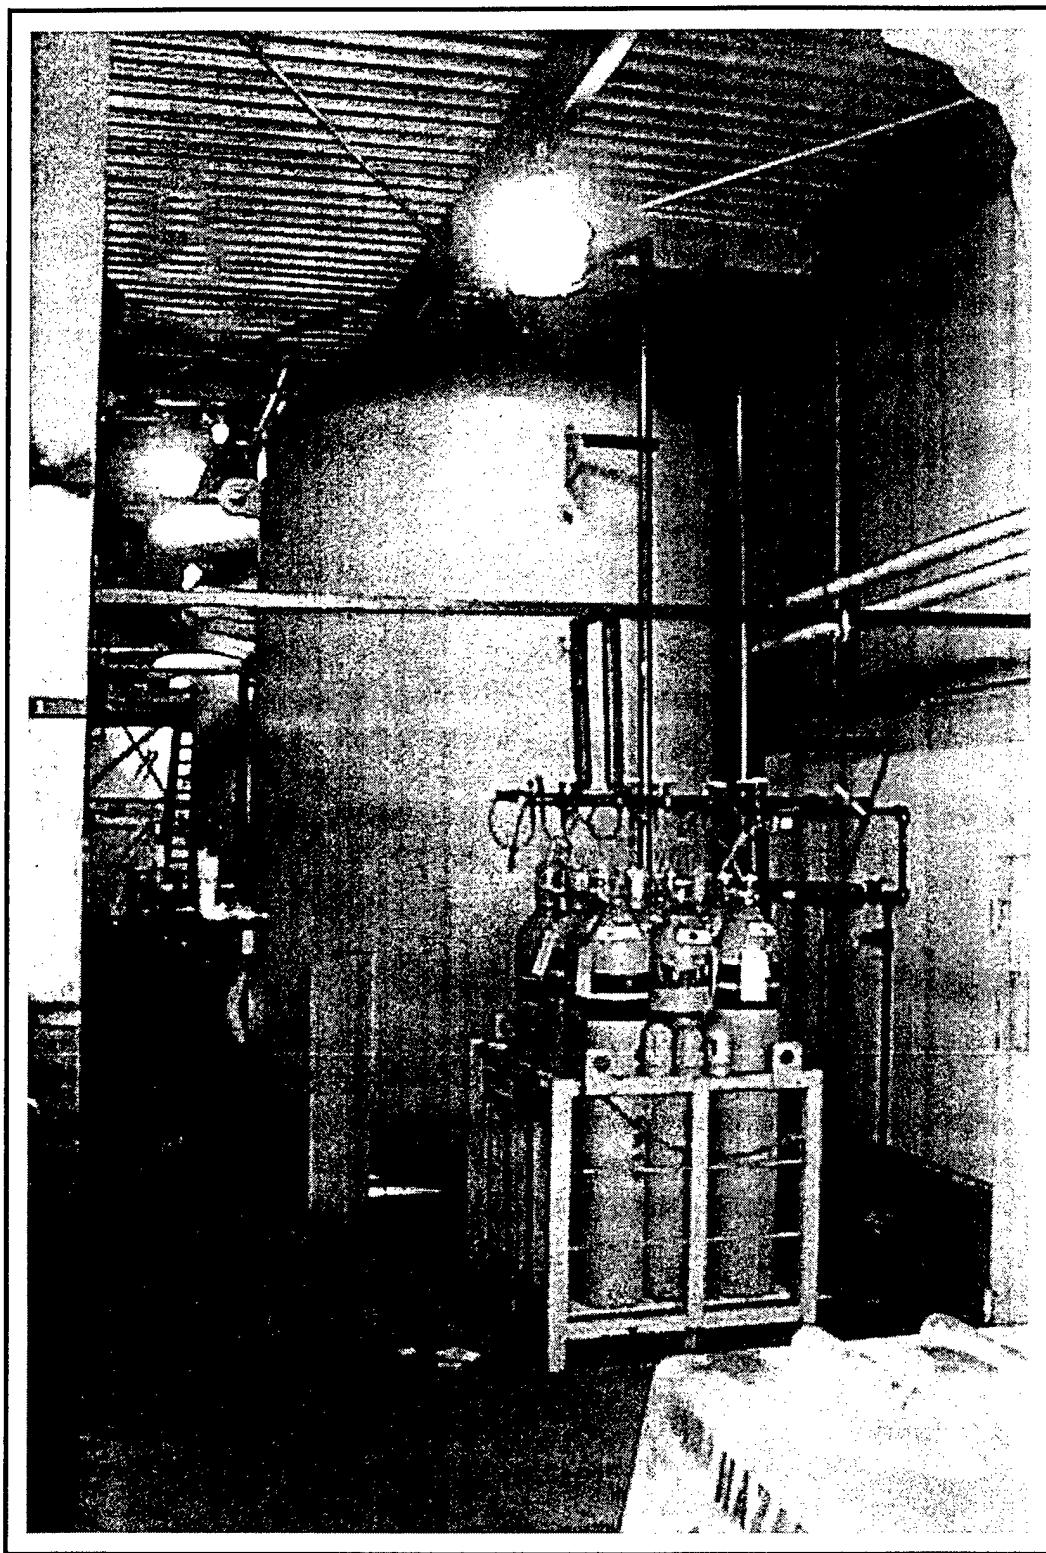
Figure 2. Nitrogen (N<sub>2</sub>) expansion tanks.

The team also recommends further investigation of how to most effectively control plant pressure during large temperature excursions. The team concurs with the plant practice of limiting operating pressure to no more than 440 psig. It may prove helpful to improve the controls on the  $N_2$  expansion tanks by adding or removing water to control pressure, in addition to adding level control for water inventory. Another option would be to increase expansion tankage so that a given level change would reflect a much smaller pressure swing.

Plant 1240 has a computerized plant data recording system that is useful for investigating plant upsets. Unfortunately, system pressure is not recorded as a trend. It is recommended that the screen interface be modified to trend plant pressure and nitrogen ( $N_2$ ) expansion tank level (Figure 2) to help operators and maintainers troubleshoot pressure control problems.

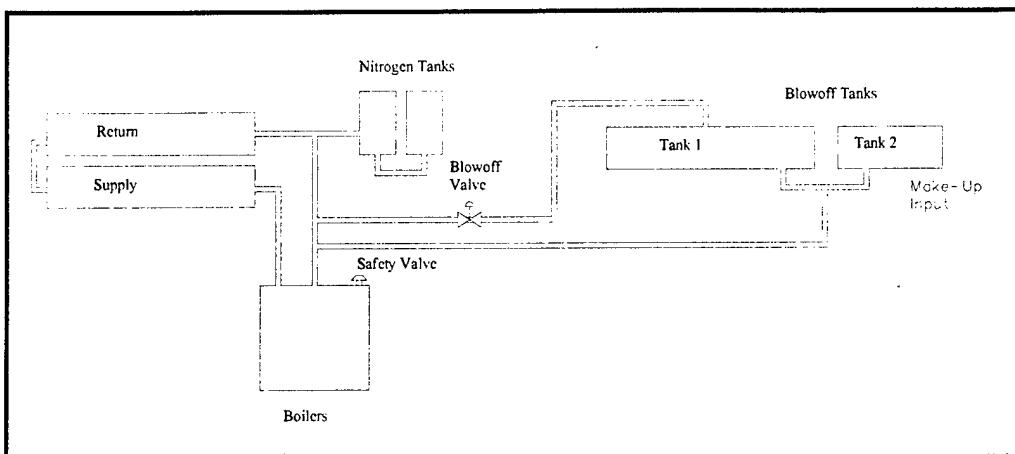
Figure 3. Plant 1240 HTHW system schematic.

The total volume HTHW distribution for Plant 1240 is 216,000 gal. There are five HTHW generators, three coal-fired units, and two gas/oil-fired units, as described in the December 1998 site visit. (Figure 3 shows a system schematic for Plant 1240.) The return temperature is typically about 350 °F at 425 psig. HTHW units are brought on line to best match the system load with the fewest number of units operating at maximum capacity. Additionally, before starting an on-coming HTHW unit, HTHW is circulated in the cold unit to heat the furnace surfaces. This reduces thermal stress and corrosion in the on-coming units. During such transitions (bringing units on- or offline), the distribution bulk temperature can vary causing the water volume to shrink or swell. Another type of event is the rapid loss of load due to a HTHW-to-steam converter being rapidly shutdown. This causes the bulk water temperature of the return and supply lines to increase, and causes the system volume to increase (i.e., to swell into the N<sub>2</sub> tank).

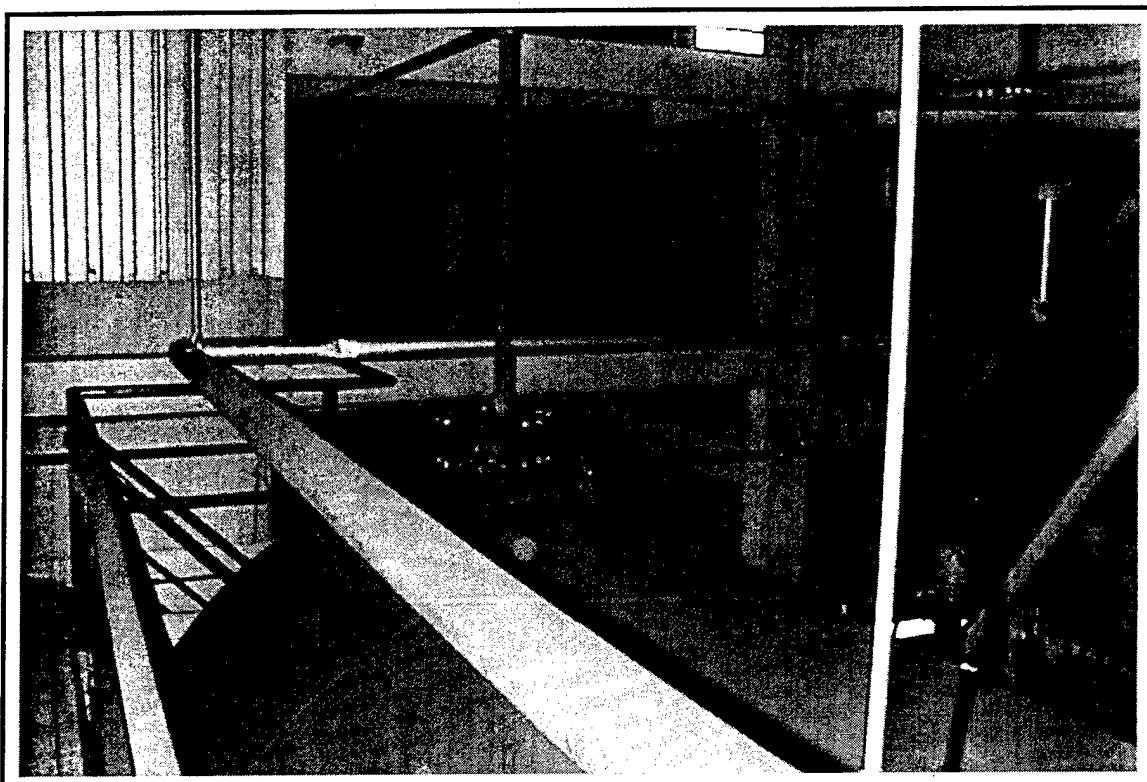
Figure 4. HTHW blowoff piping.

The current discharge piping arrangement (Figure 4) experiences large vibrations when discharging HTHW to the blowoff tank (Figure 5). When a transient necessitates discharge of HTHW, the blowoff valve (Figure 6) opens to release water at 350 °F and 440 psig to near ambient conditions. The pressure at the outlet of the valve will be slightly above ambient conditions due to flow resistance, but the increase in pressure will not be sufficient to prevent some of the HTHW from flashing to vapor. At 350 °F, steam occupies about 180 times more space than liquid water. Although only about 20 percent of the HTHW will flash to steam at atmospheric pressure, the acceleration of the two-phase mixture in the discharge pipe will cause severe water hammer.

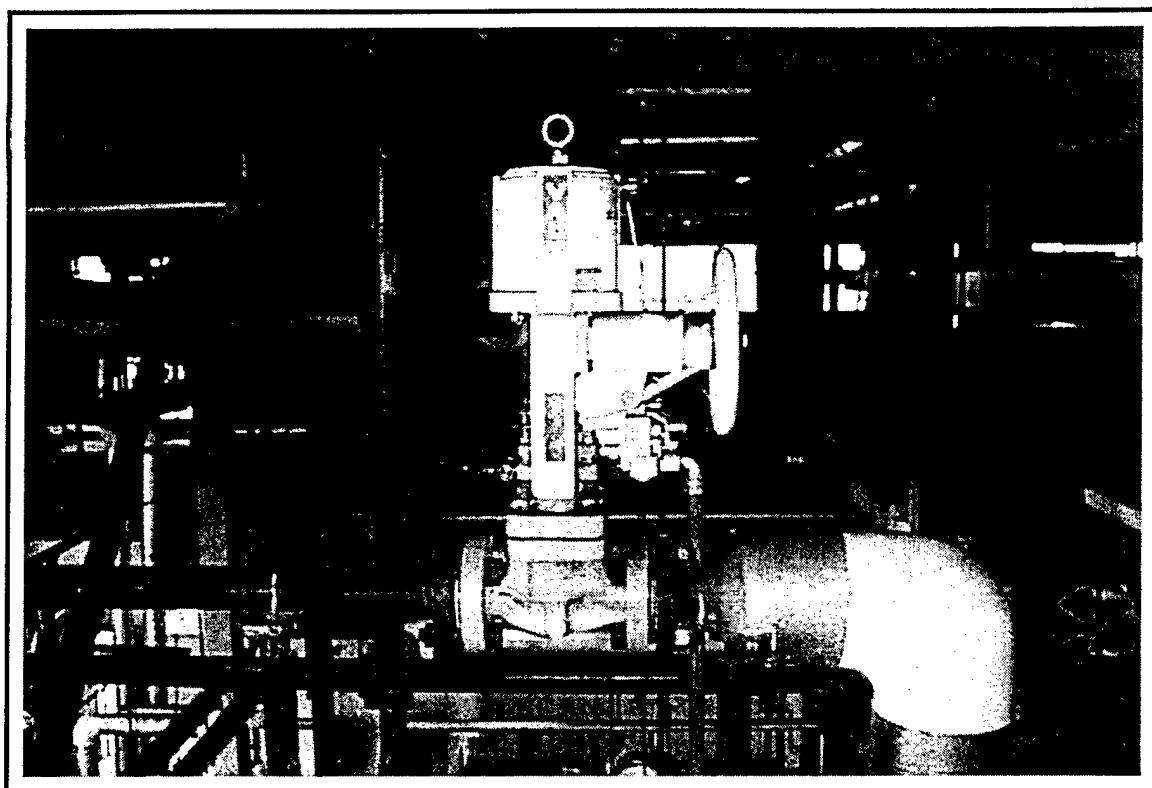
Figure 6. HTHW blowoff valve.

The team and plant staff concluded that the valve is not placed in the best position to minimize water hammer when discharging HTHW to the blowoff tanks. The team recommended that the blowoff valve would have the least water hammer when located to discharge into the top of the blowoff tank (Figure 8). This would eliminate two-phase flow in the discharge line from the blowoff valve to the blowoff tank.

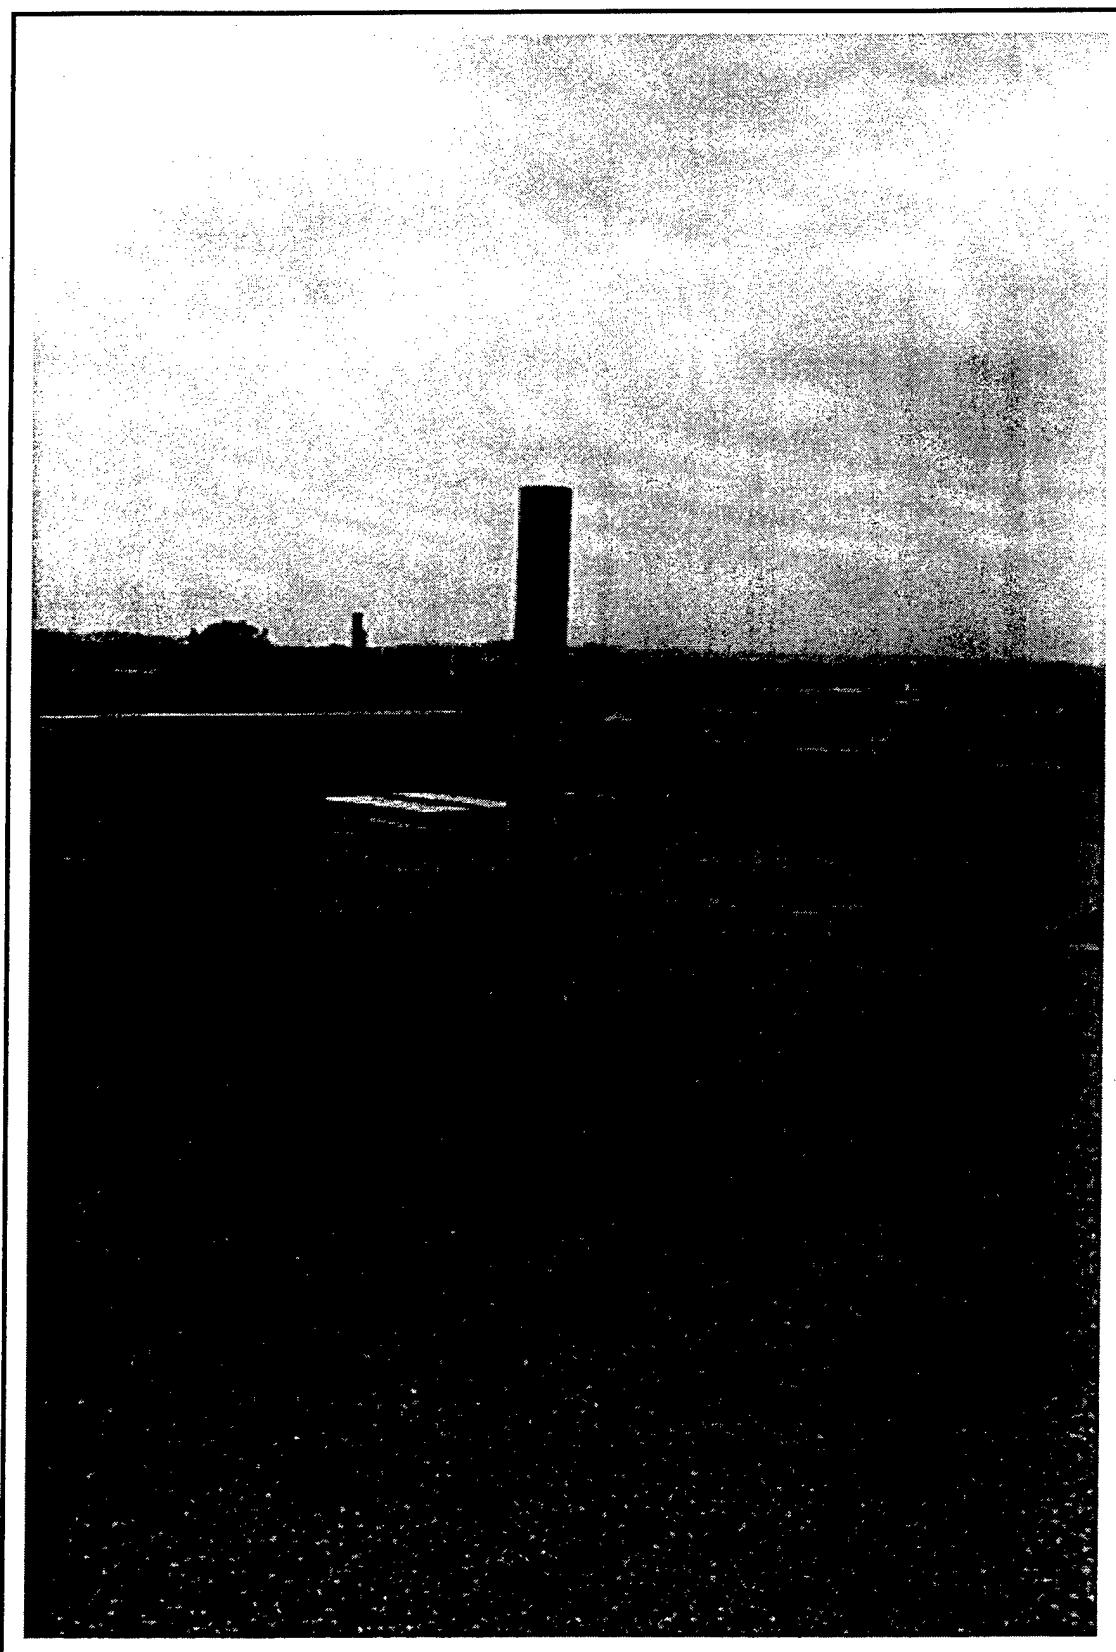
Figure 7. Blowoff tank vent on the roof of Bldg 1240.

The plant staff was also concerned that the present location and size of the overflow piping of the blowoff tank could cause damage to the plant roof. The steam created when the HTHW flashes into steam is vented out of the blowoff tank to the roof (Figure 7). The roof was inspected; currently there appears to be no damage to the plant roof. However, should there be prolonged venting, vent drains and piping should be installed to minimize exposing the flat roof to hot water and steam. If needed, SAI can provide drawings and specifications of typical vent drains.

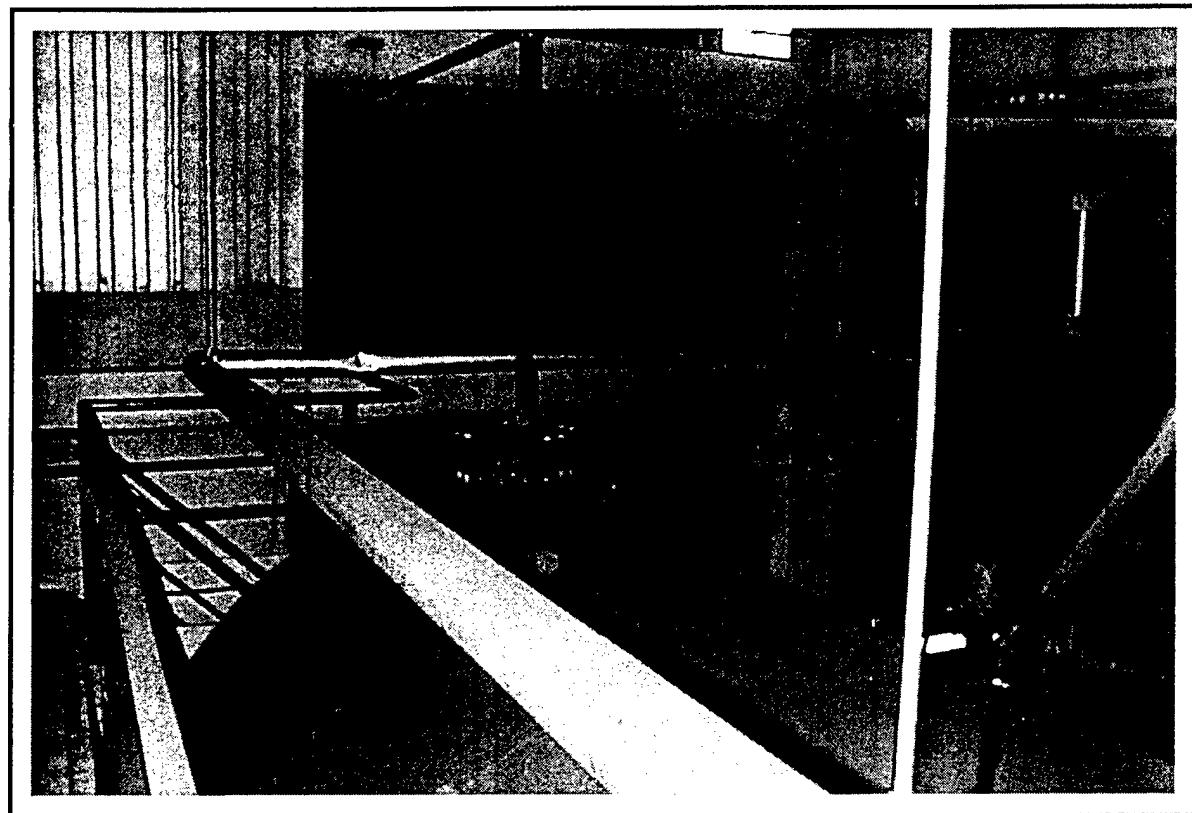
Figure 10. Current blowoff tank bracing.

Regardless of what solution WPAFB selects, the system needs to be modified to eliminate HTHW blowoff line water hammer. Additionally, the pipe anchoring needs to be corrected to allow for thermal expansion. The current bracing (Figure 10) seems to over-constrain the piping that was vibrating due to water hammer. The pipe needs to be allowed to expand along its length to prevent bowing in the pipe. This could be done with a three-sided rectangular piece of metal. The three-sided rectangular piece of metal should be as long as the pipe itself. The pipe should be placed between the two opposite sides of the piece of metal. The pipe should then be anchored with some u-bolts that will clamp the pipe to the piece of metal.
